# the Bidwell House museum

## Spring 2017 Restoration Update

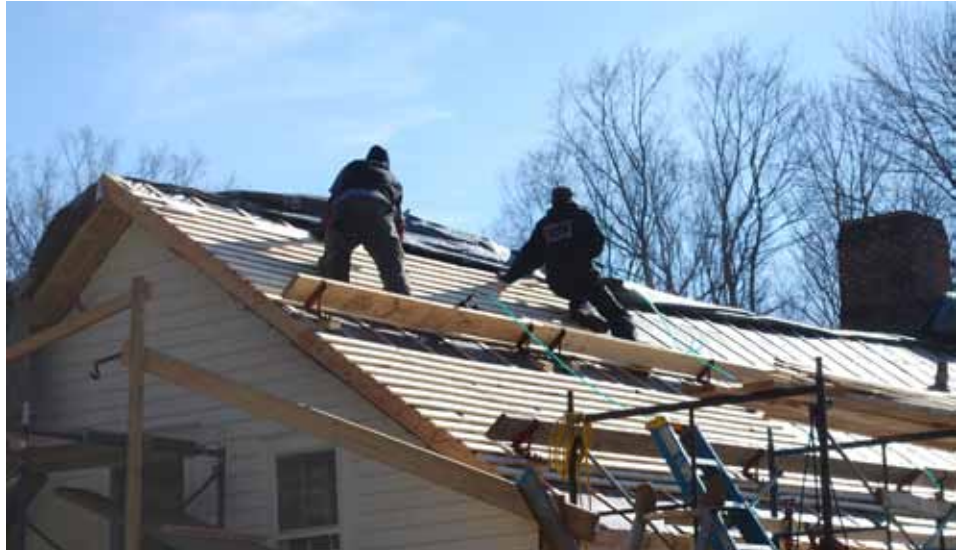
*Installation of the breathing grid on the 1820s ell*

Thanks to the generosity of the museum's donors, the building restoration is progressing well. The front roof of the main house was completed just before New Year's, helped by cooperation from the weather gods. This included the installation of a layer of plywood and a breathing grid between the original sheathing boards and the new, historically appropriate cedar shingles. Custom-made steel joint supports in the attic will prevent further leaning of the building. On the rear ell, roof overhangs that had been removed in the 1960s were replaced.

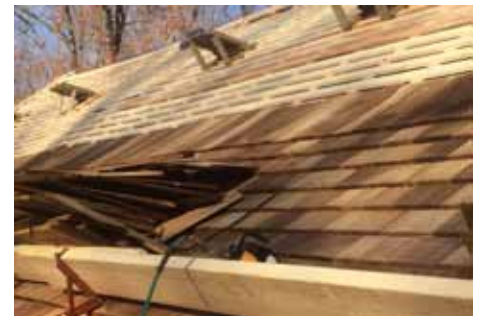
*New cedar shingles on the front roof*

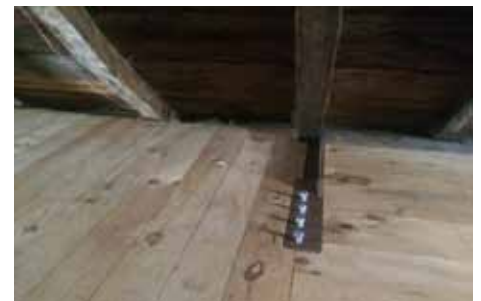
*Steel joint support in the attic*

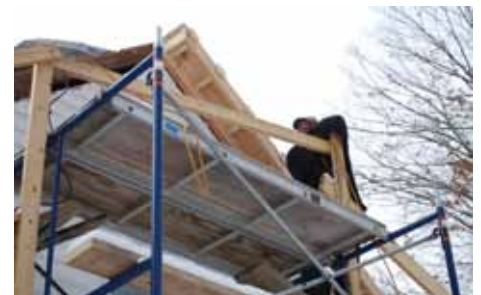
*Replacement of roof overhangs on ell*

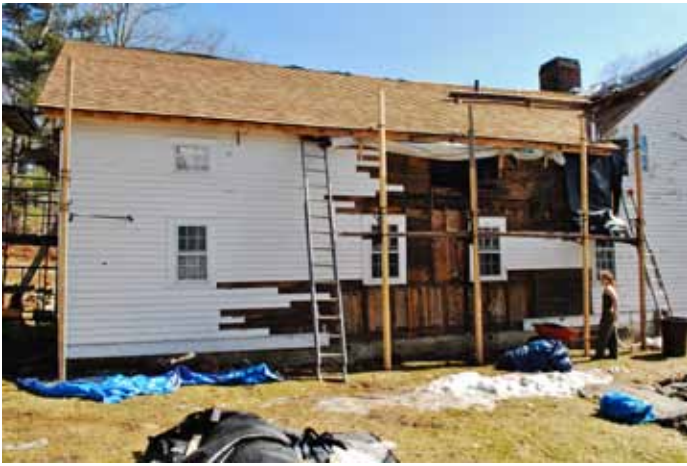
On February 23rd, significant rot was discovered in the west wall of the ell (see photos). Repairs will require replacing two more beams, studs, sheathing and siding and two window frames. But an interesting result of uncovering the west wall

*Exposed west wall of the 1820s ell, with completed roof*

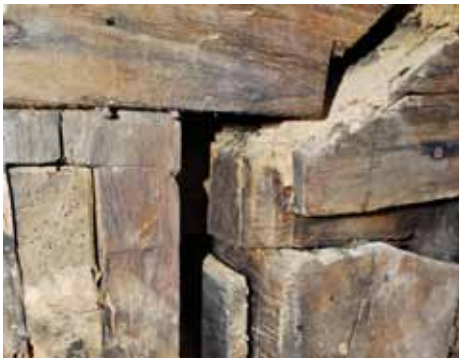
was revealing the juncture between the original 1760s saltbox frame and the 1820s ell (see photo on reverse).

*Juncture between 1760s and 1820s frames*

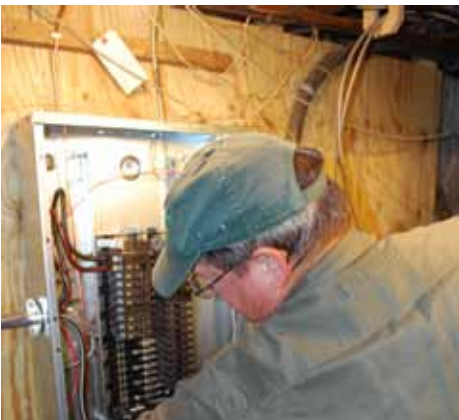
Inside, the garret walls were opened to install insulation in the area with the most serious ice damming problems. Electrical wiring was replaced throughout the museum, and the electric panel moved to the cellar. The office, in the upstairs of the 1820s ell, was gutted. New insulation will greatly reduce heat loss here.

*Installation of the new electrical panel*

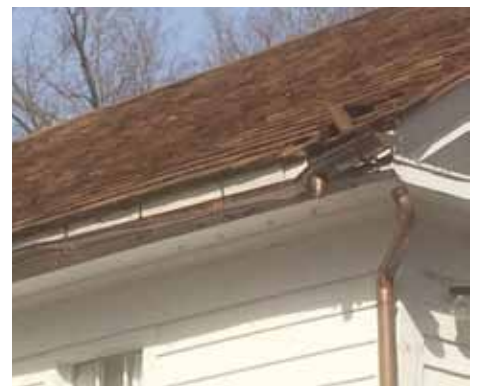
Then, on February 25th, the weather gods sent an "undetermined weather event" right across the Bidwell House Museum property, downing numerous trees and narrowly missing the house itself. Debris slammed into the gutter and roof of the 1840s wing with such force that the gutter is crushed and the roofing damaged. The storm also tore off the power and phone lines, sparking an electrical surge that damaged the furnace and computers.

Unfortunately, the damaged roof

and destroyed gutters were brand-new, installed in Phase 1A restoration this past spring. Total damage to the building is likely to be \$30,000. The museum is counting on insurance help. Damage to trees has not been totaled. Suffice it to say, there is months of chain-sawing and enough fire wood for the whole neighborhood. The museum is also applying for emergency aid from the Massachusetts Historical Commission to help pay for the unexpected beam replacements.

*Crushed gutter and roof damage*

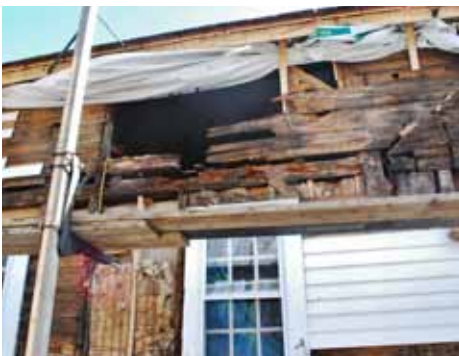
*Moisture damage in the west wall*
